Wide Bay Burnett Conservation Council Inc.

**WIDE BAY WATER CORPORATION
CONTRAVENTION OF SECTION 813 (1)
QUEENSLAND WATER RESOURCES ACT 2000**

25TH JUNE 2008
25 ELLENA ST
MARYBOROUGH
4650

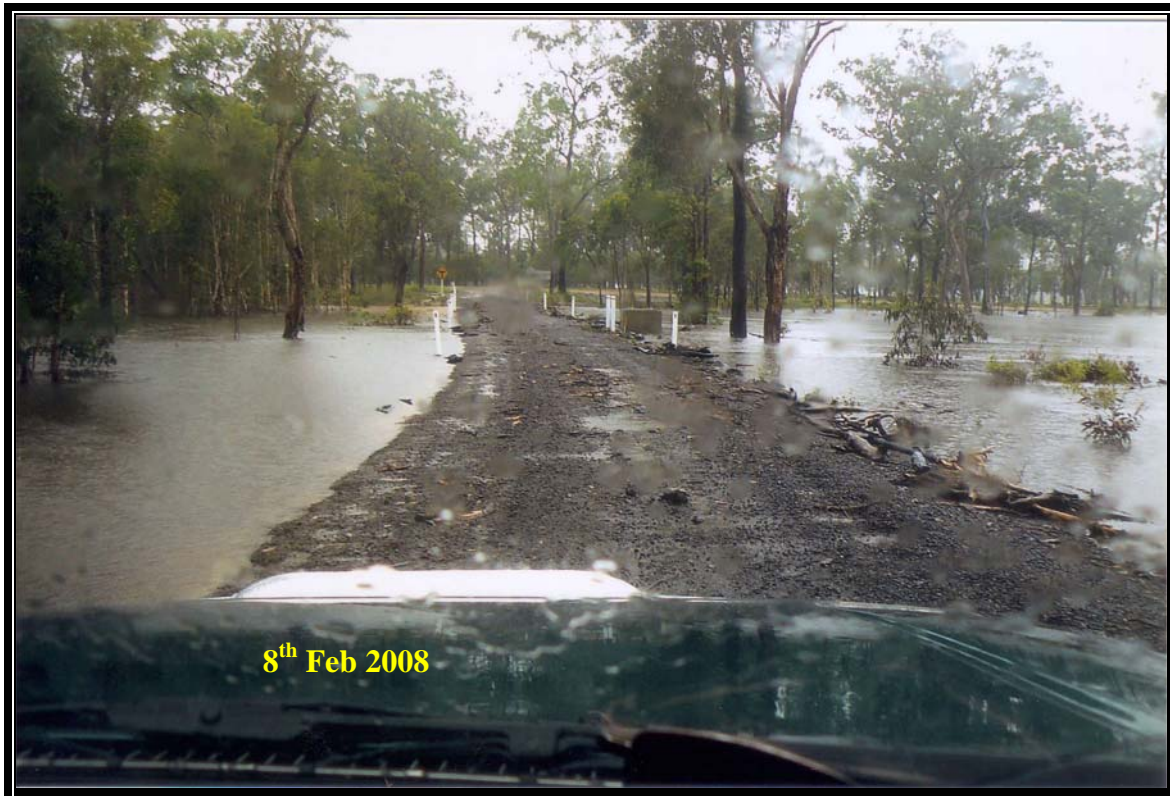
This Image taken by a long term resident in the Wongi area , on the 8th feb 2008 , clearly shows that the water level at Wongi Water Holes (on the left) had overtopped the loop rd at RL 26.5. This is 96 hrs previous to the Dam Wall reaching RL 27.4 on the 12 th Feb 2008.

Due to crest gate failure on Feb 6th 2008² , dam water levels reached 26.55m , this resulted in the water levels at Wongi Waterholes being elevated to RL 27 .The letter indicates that water levels at the Dam wall remained at this height until 16th Feb 2008.

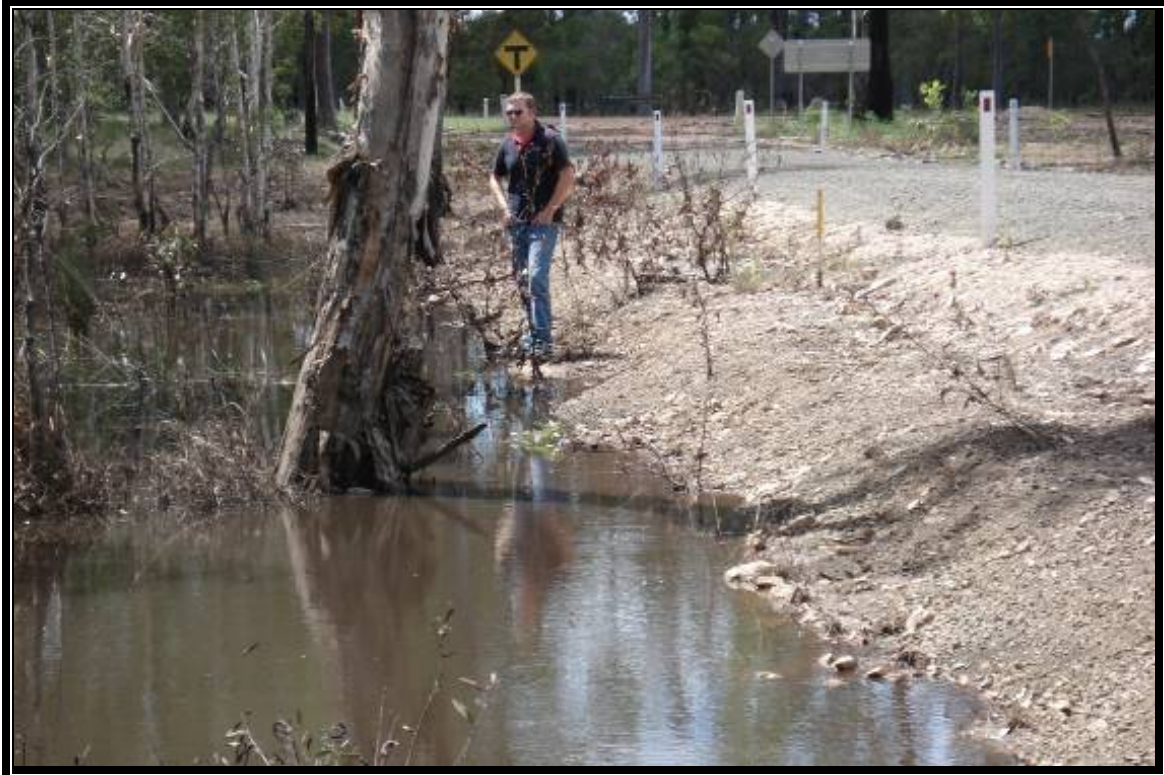
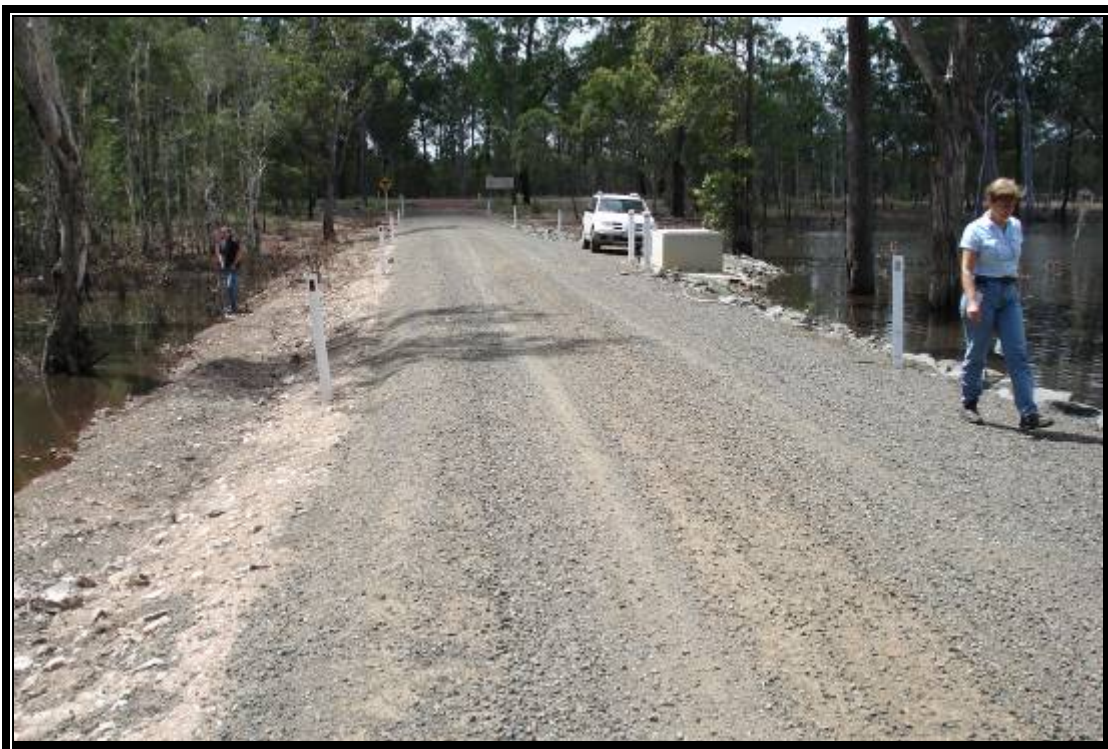
The images below were taken by NRW staff present at the Loop rd on in early March .

From the evidence available it can be demonstrated that Wongi Water Holes were inundated from 5th February 2008 until post 22nd February 2008, based on the above

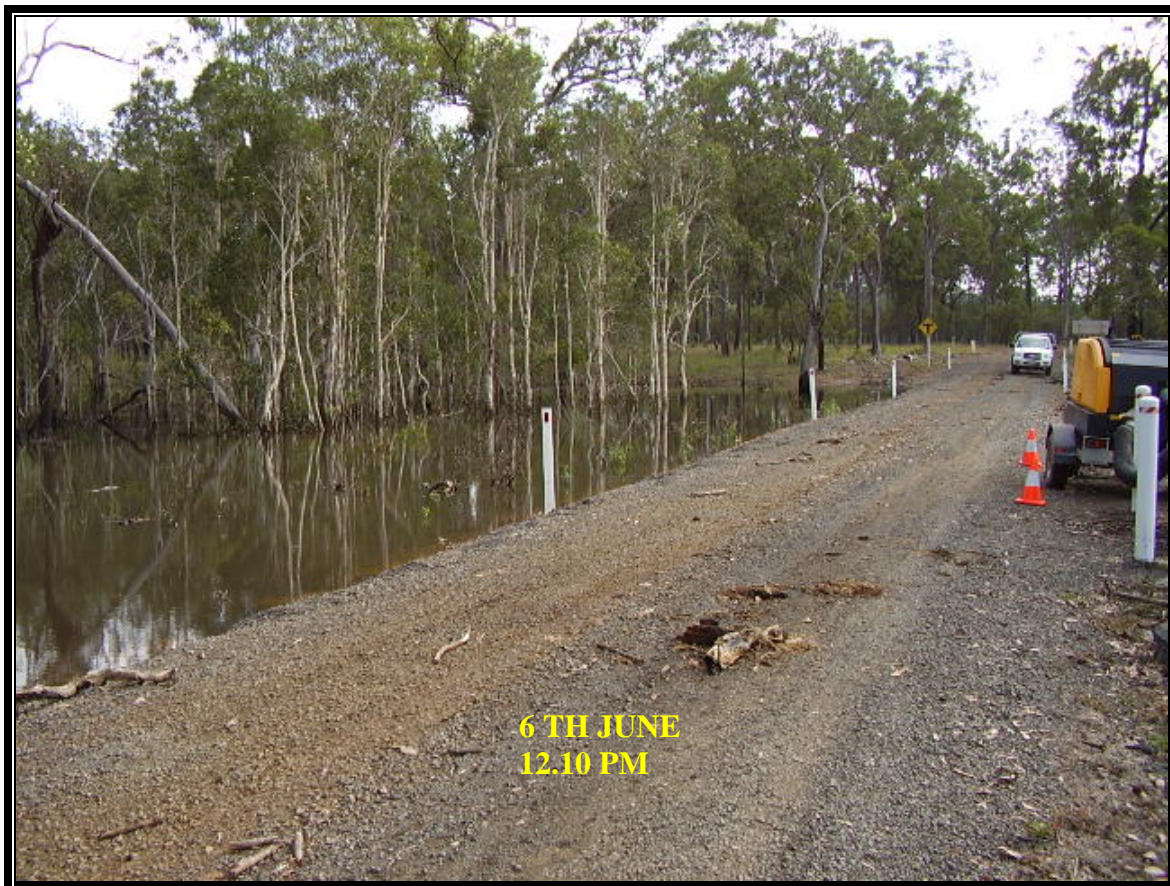
The rainfall event on June 1st -3rd resulted in the water level overtopping the loop rd (> RL 26.5, possibly > RL 27) as indicated in the image below , taken 3 days later , clearly indicating flood debris still present on the loop rd

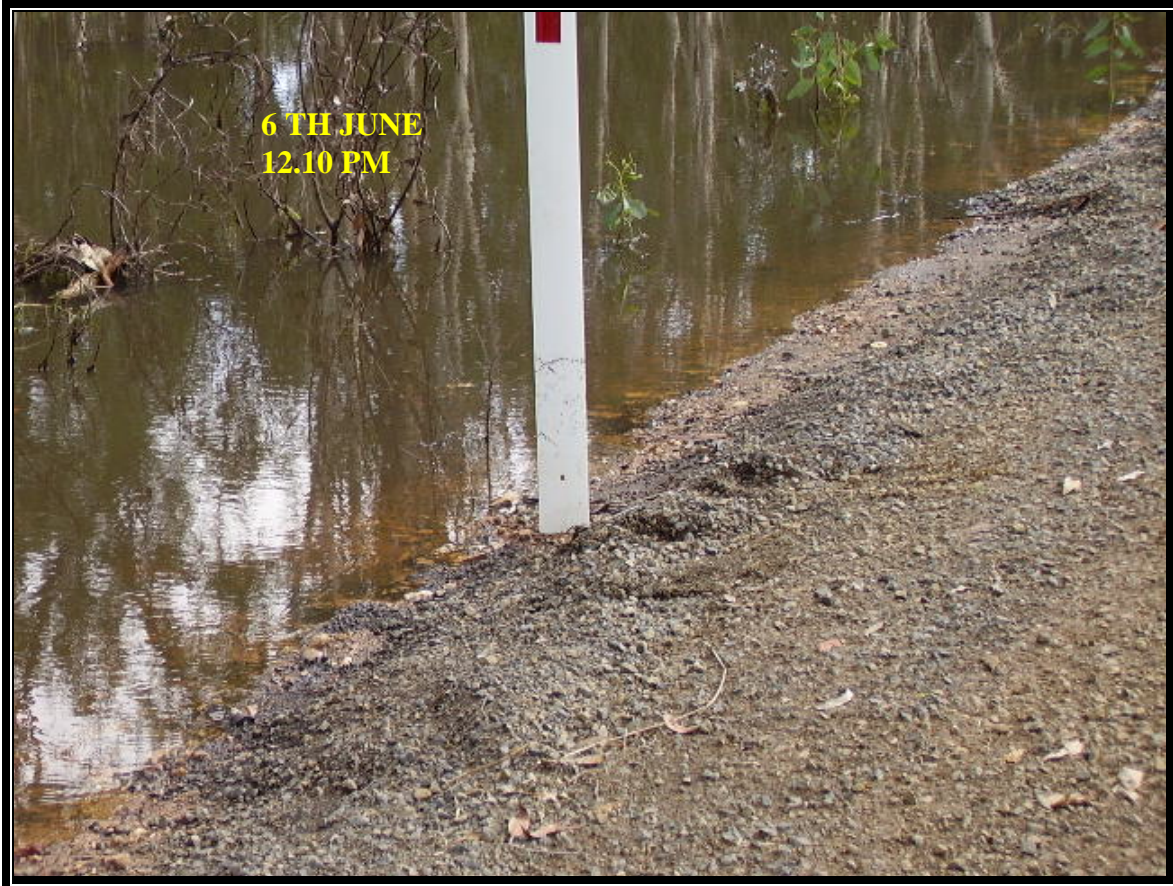
This image shows the water level on the Wongi Water Holes side , level with the white guide marker .

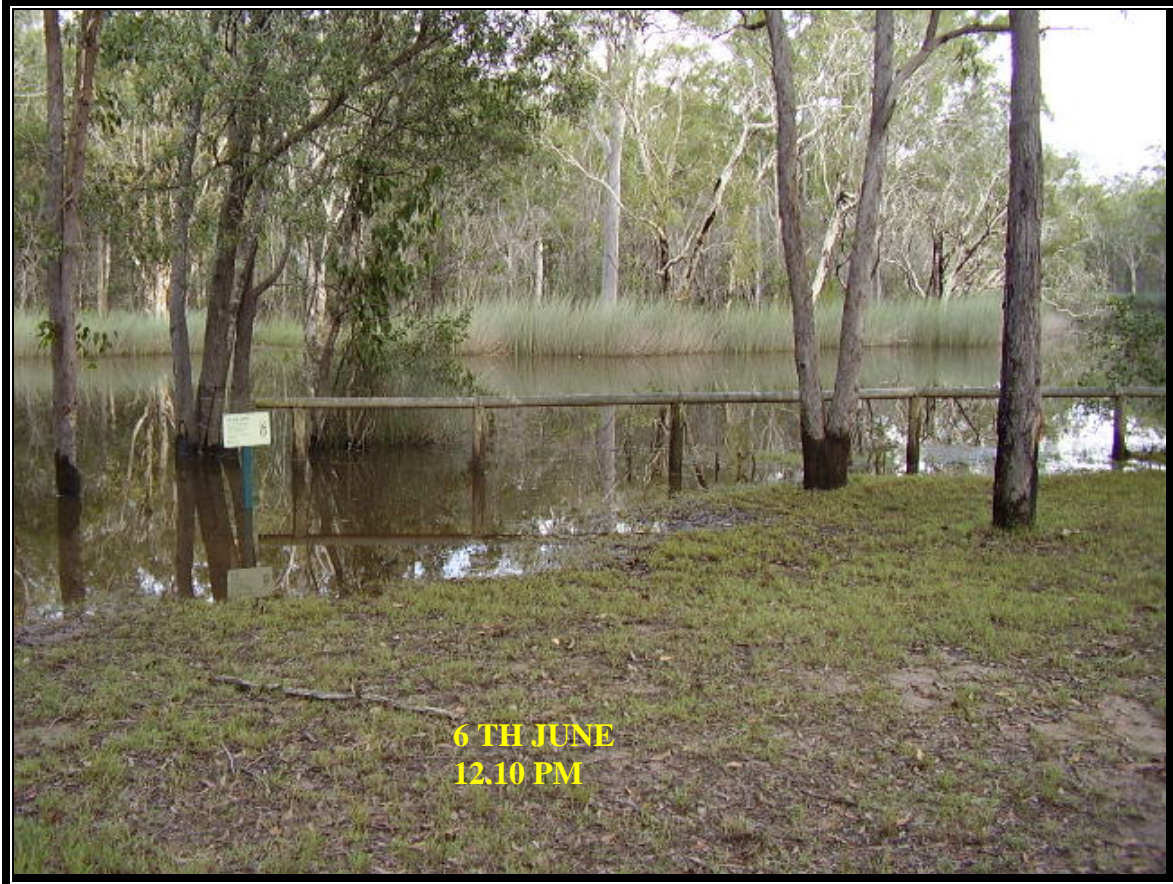
This image is approximately 400m upstream of the loop rd and indicates that the levels had been 800mm higher (based on the markings on the forked *Corymbia Intermedia* to the right of the sign), which would equate to > 500mm / RL 27 over the loop rd,

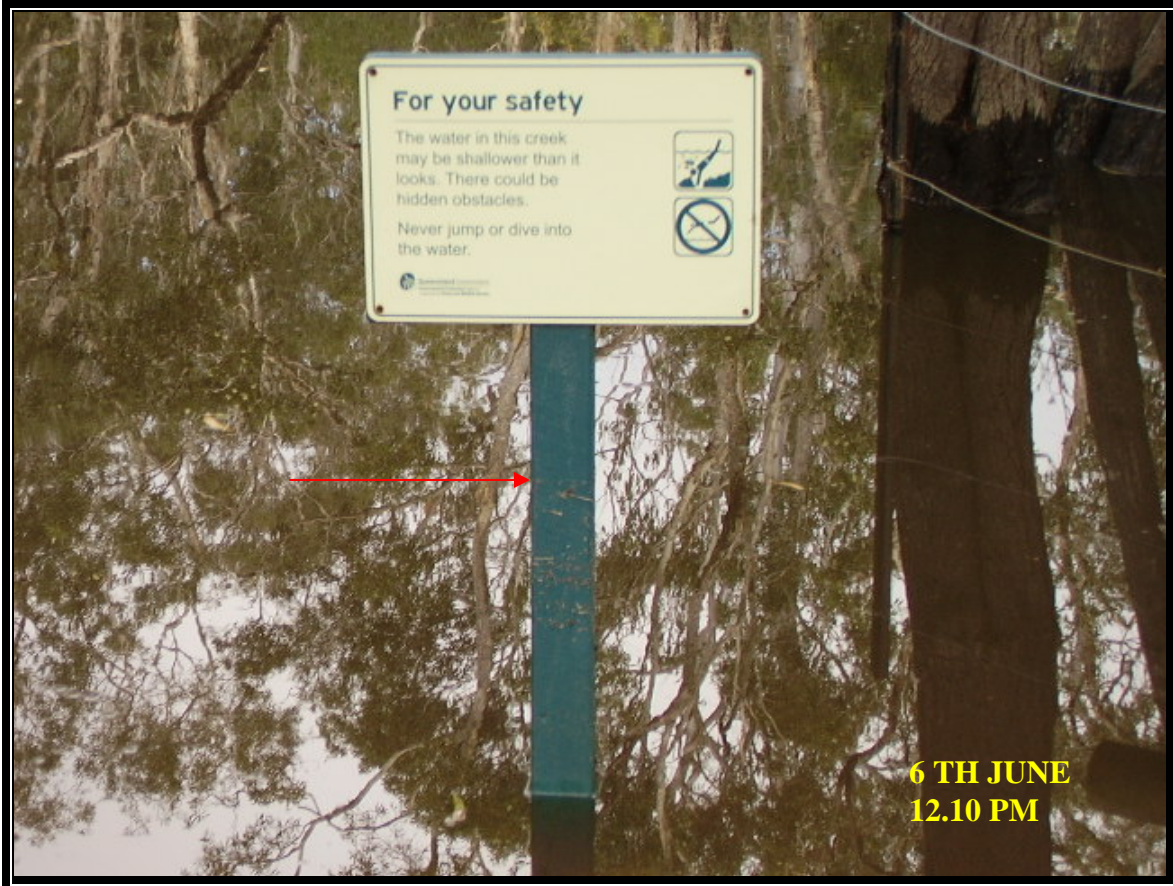
Image close up , arrow indicating previous water level.

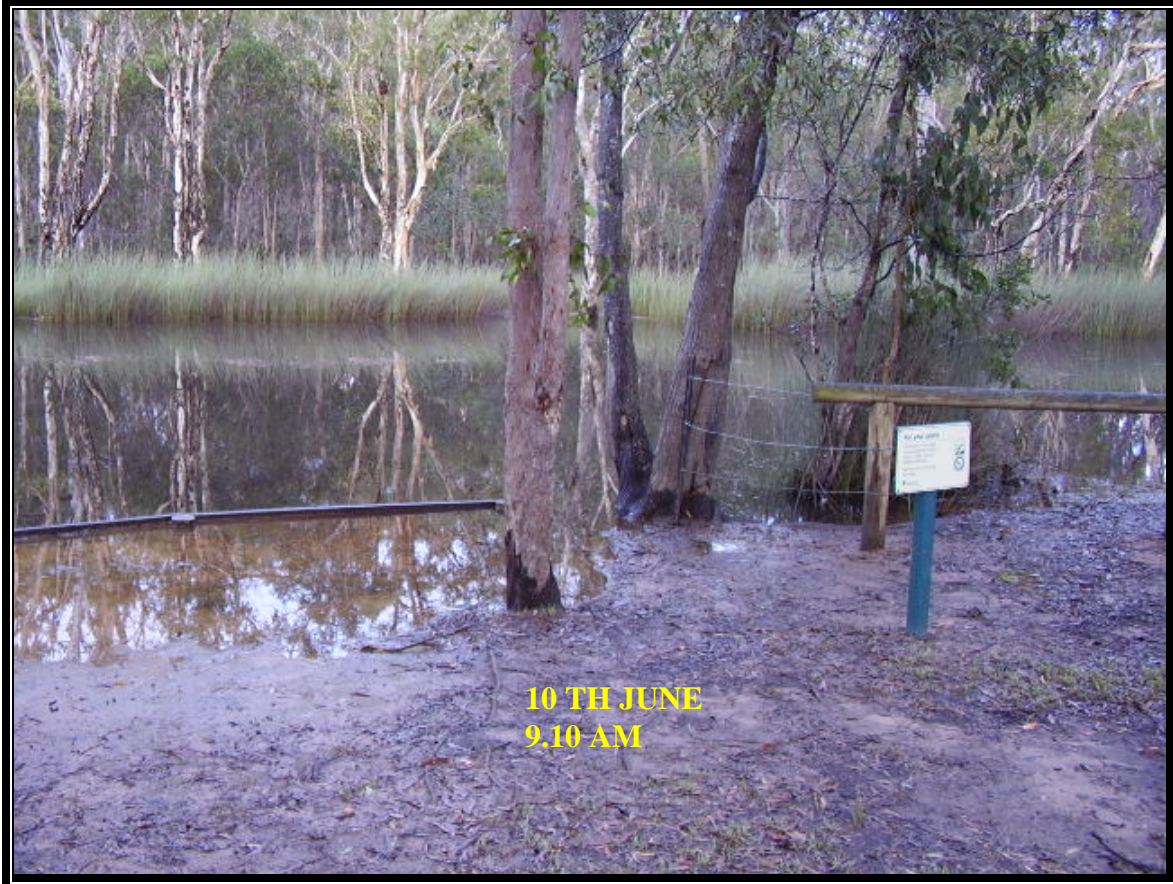
This image indicates that 4 days after the levels indicated on the 6th June, the level had fallen by 400mm (extraction rate = 100 mm per day) .

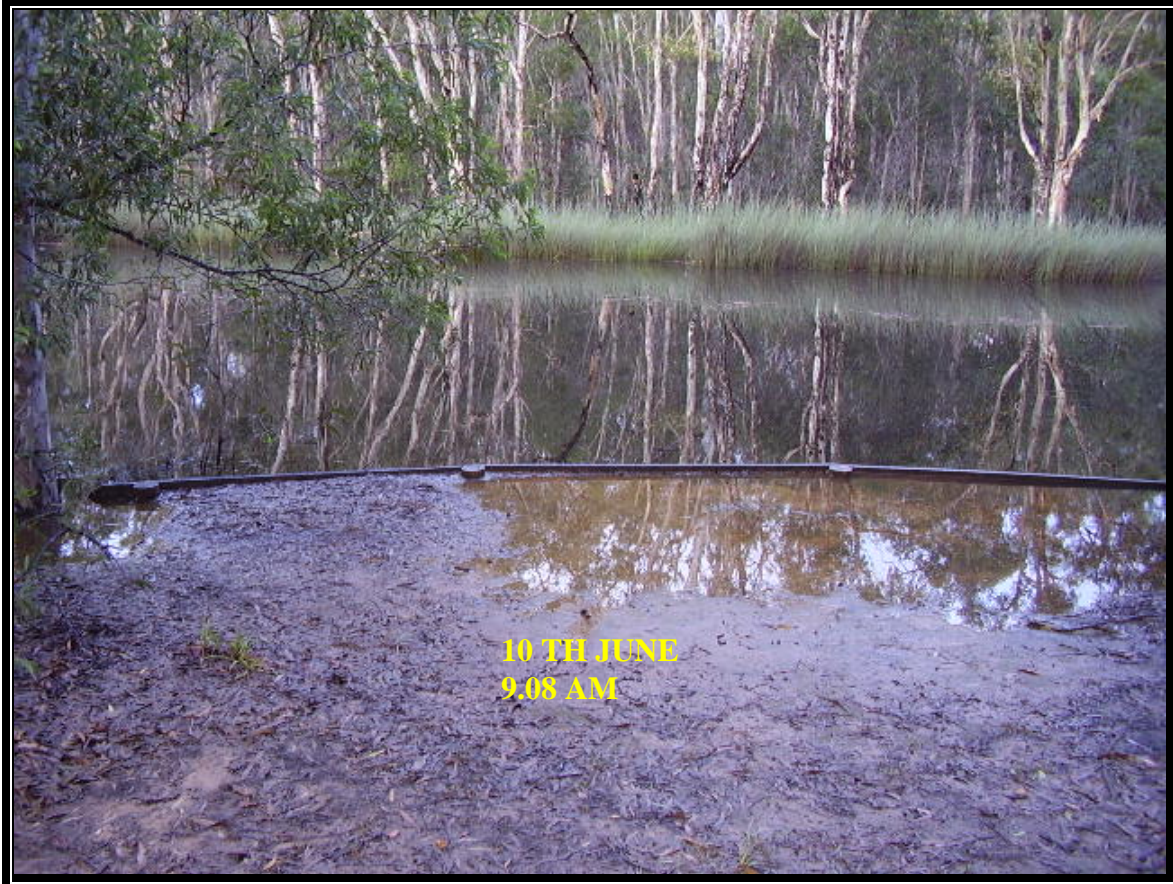
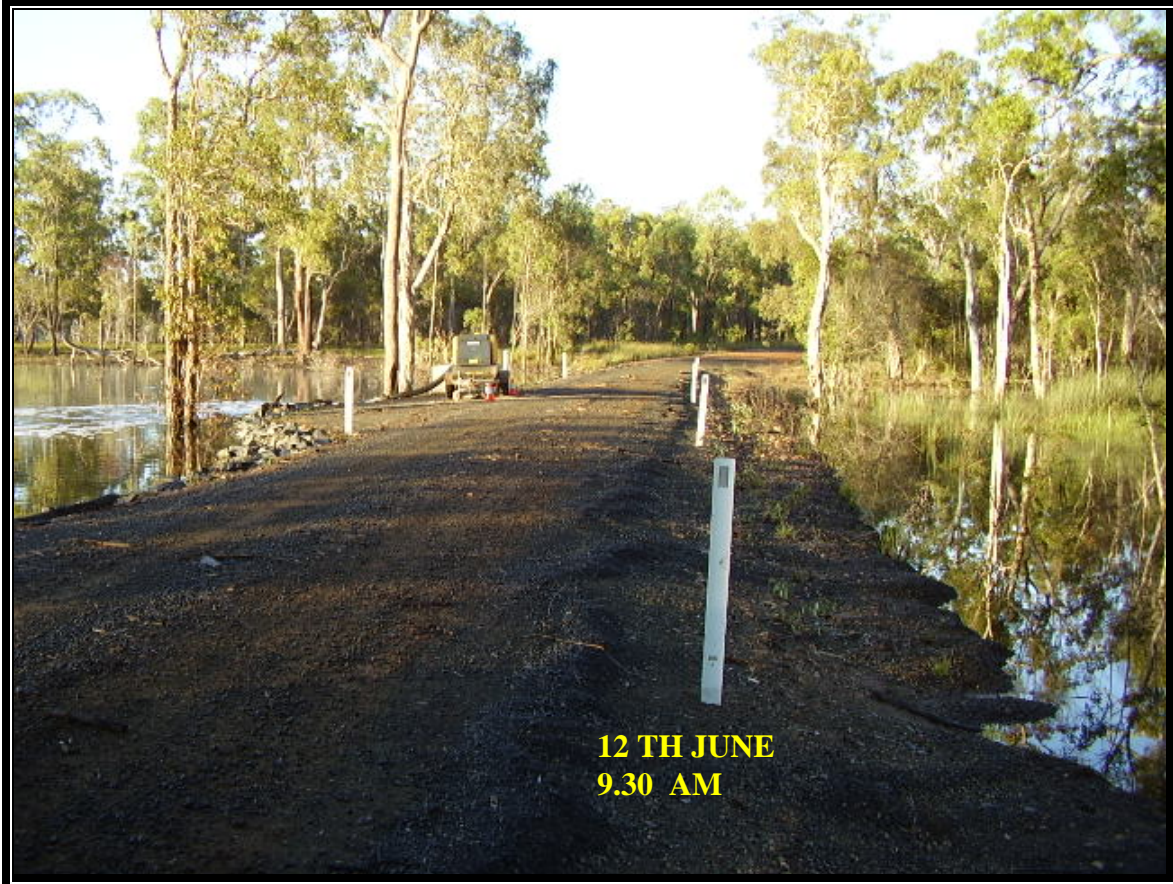
This image indicates that the water level is ca 400mm lower than the level of 6 th june , six days earlier . (extraction rate 66mm per day)

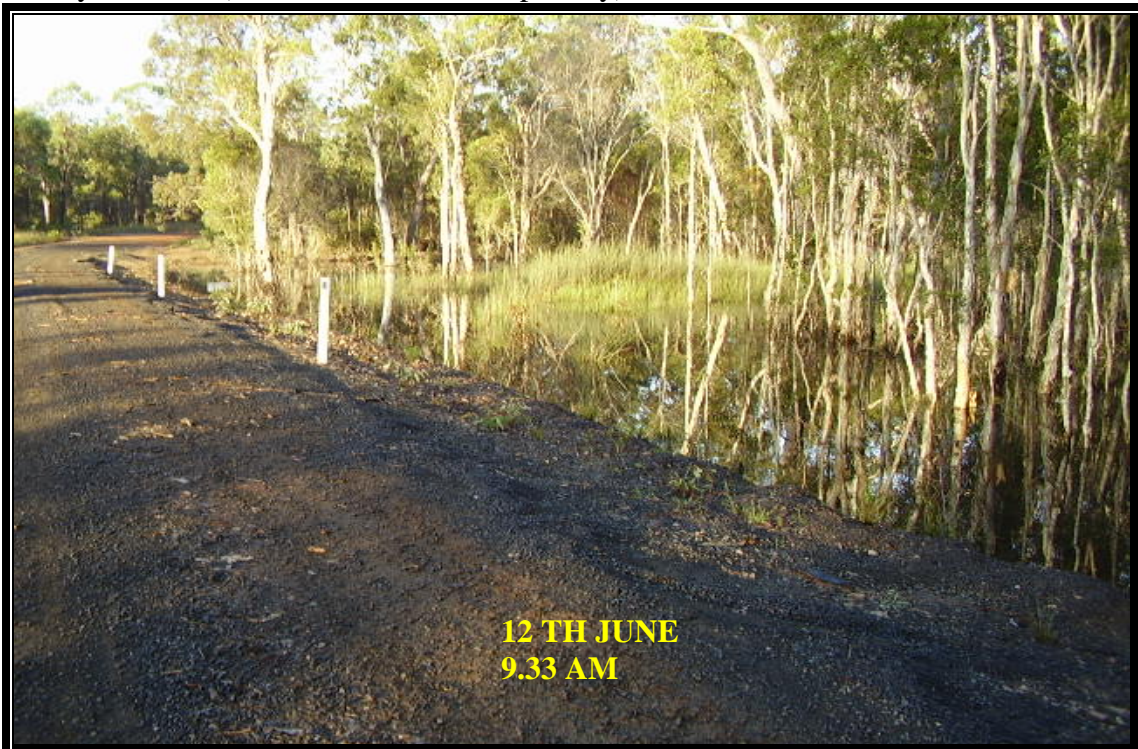
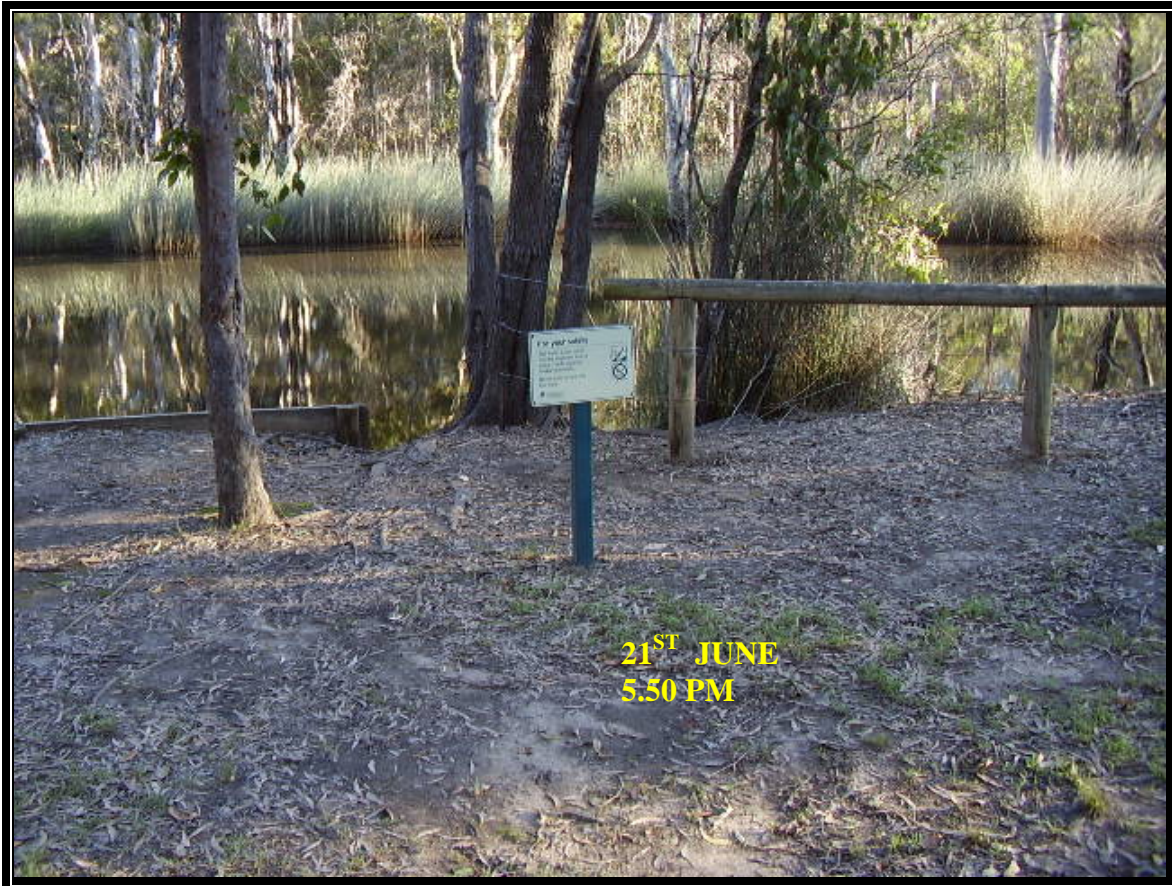
This image taken 9 days after the 12th June, and 15 days after the 6th of June, indicates that the water has returned to a natural level.
